Manhole Inspection Summary

Manhole # S31M__016MH

Insp Date: **12/26/08 10:00 AM**

Location Address: **W Conway St**

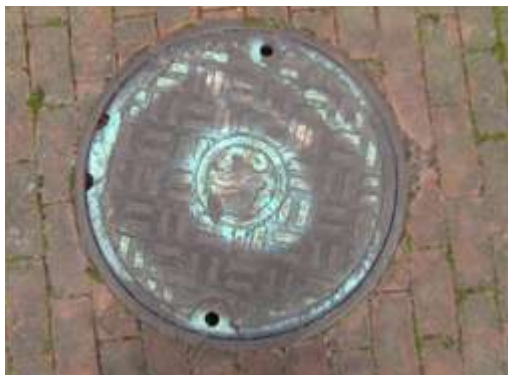
Miscellaneous

MH cover

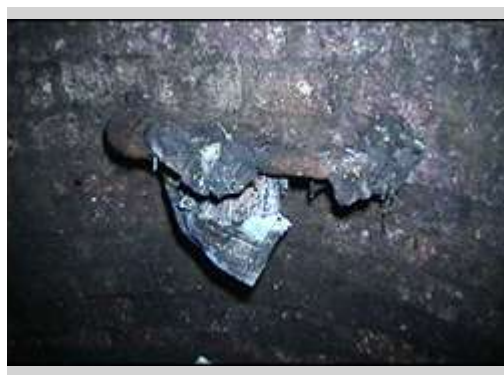
Defect 2

Steps Count: **8** Missing: **0** ☒ **Corroded**

Surcharge ☒ **Evidence Of Surcharge** Depth: **3** (ft.) ☐ Active Surcharge Present

corroded step, signs of surcharge

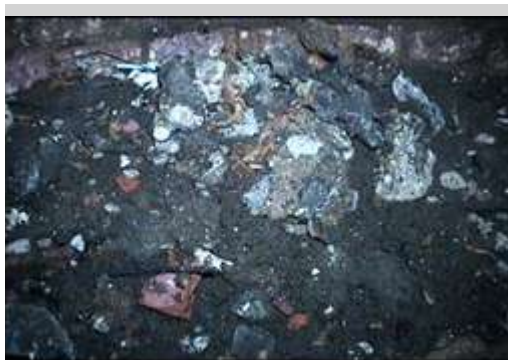
Defect 1

Condition: ☐ Sound ☐ Cracked ☐ Root Intrusion ☐ Deteriorated ☐ Leaks ☒ **Debris**

debris on bench

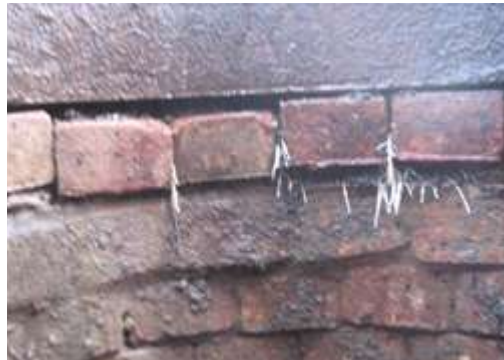
Defect 5

chimney infiltration at mortar, roots

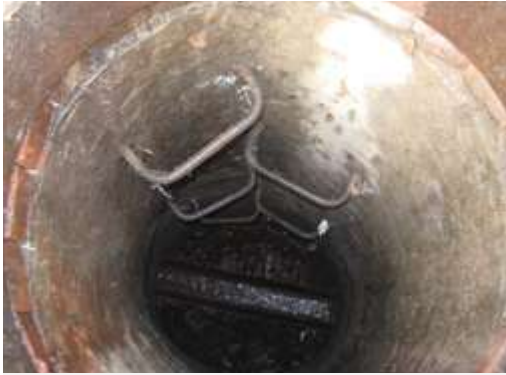
Defect 4

chimney infiltration at wall

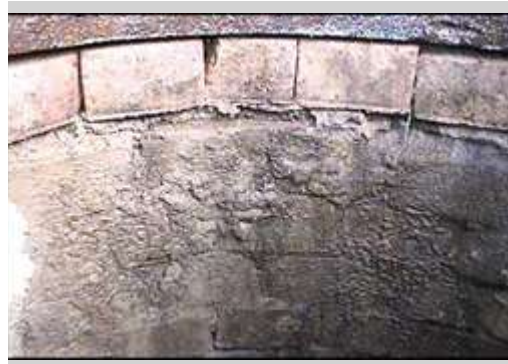
Defect 3

Frame Offset: **0** (in.) Condition: ☐ Sound ☐ Cracked ☒ **Leaks**

Condition: ☐ Sound ☒ **Cracked** ☒ **Root Intrusion** ☒ **Loose Brick** ☐ Deteriorated

frame infiltration at cover, chimney cracked, loose bricks, infiltration at frame joint

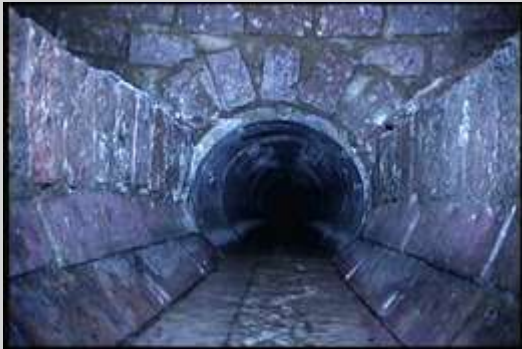
12 O'Clock Outflow

10 in. Circular Gravity Sewer
Pipe Out @ 12 O'Clock

Pipe Height: **10.8** (in.) Rod and Bar (Angled)
Pipe Material: **Clay** ☐ Pipe Lined
Invert Depth: **12.86** (ft.) Flow Characteristics: **Fast**
Deposits: ☒ None ☐ Mud ☐ Sludge ☐ Debris ☐ Grease
Silt Depth: **0** (in.) Deposits Extent:
Infiltration: **None** Pipe Seal Cond: **Sound**

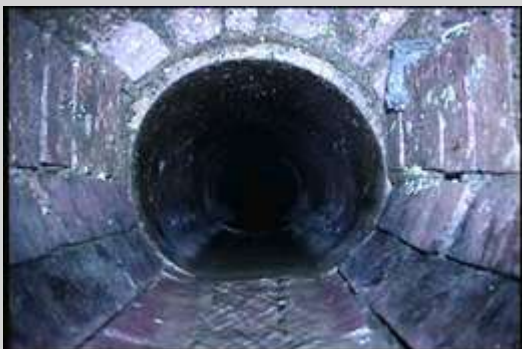
6 O'Clock Inflow

10 in. Circular Gravity Sewer
Pipe In @ 6 O'Clock

Pipe Height: **10.8** (in.) Rod and Bar (Angled)
Pipe Material: **Clay** ☐ Pipe Lined
Invert Depth: **12.78** (ft.) Flow Characteristics: **Fast**
Deposits: ☒ None ☐ Mud ☐ Sludge ☐ Debris ☐ Grease
Silt Depth: **0** (in.) Deposits Extent:
Infiltration: **None** Pipe Seal Cond: **Sound**
